## **ADVISORY CIRCULAR**

43-16A

# **AVIATION MAINTENANCE ALERTS**

**ALERT  
NUMBER  
341**

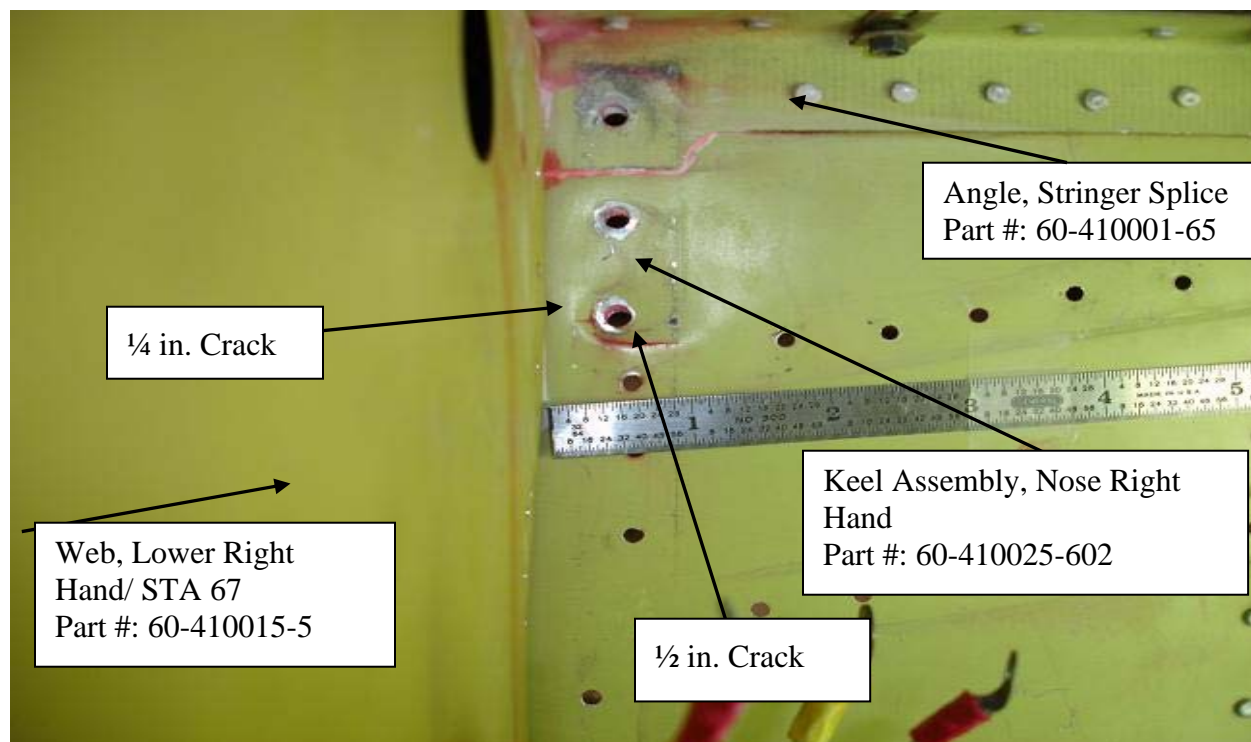
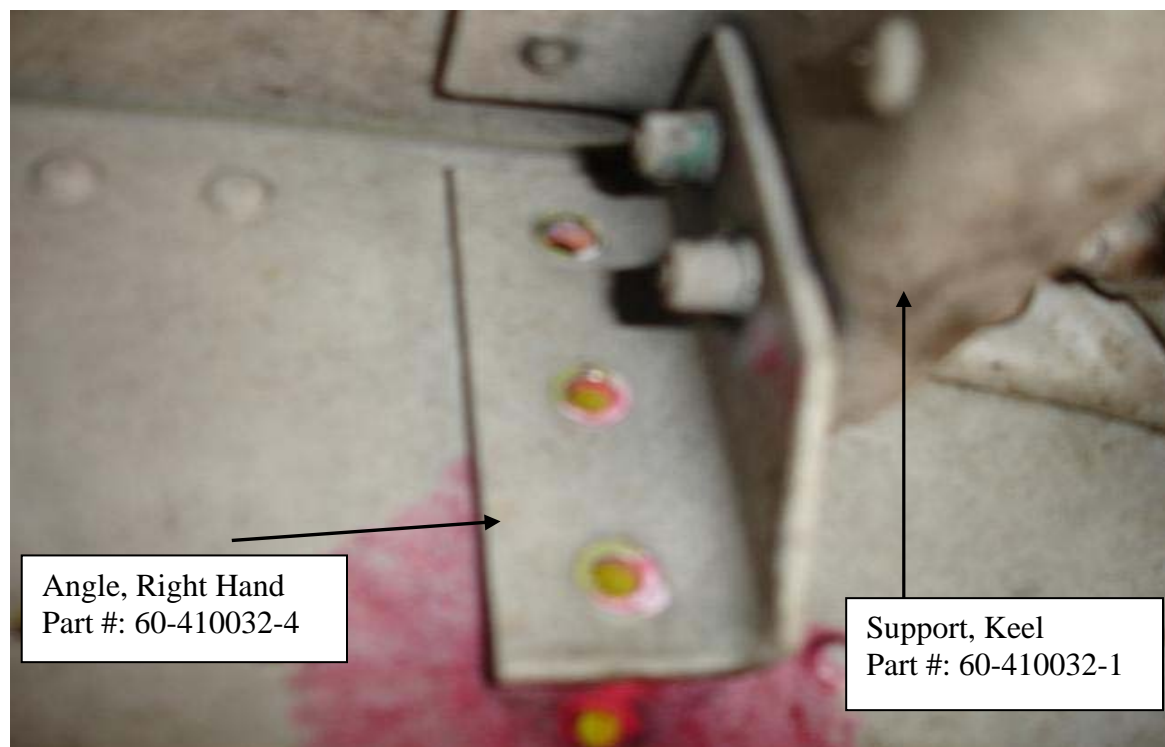
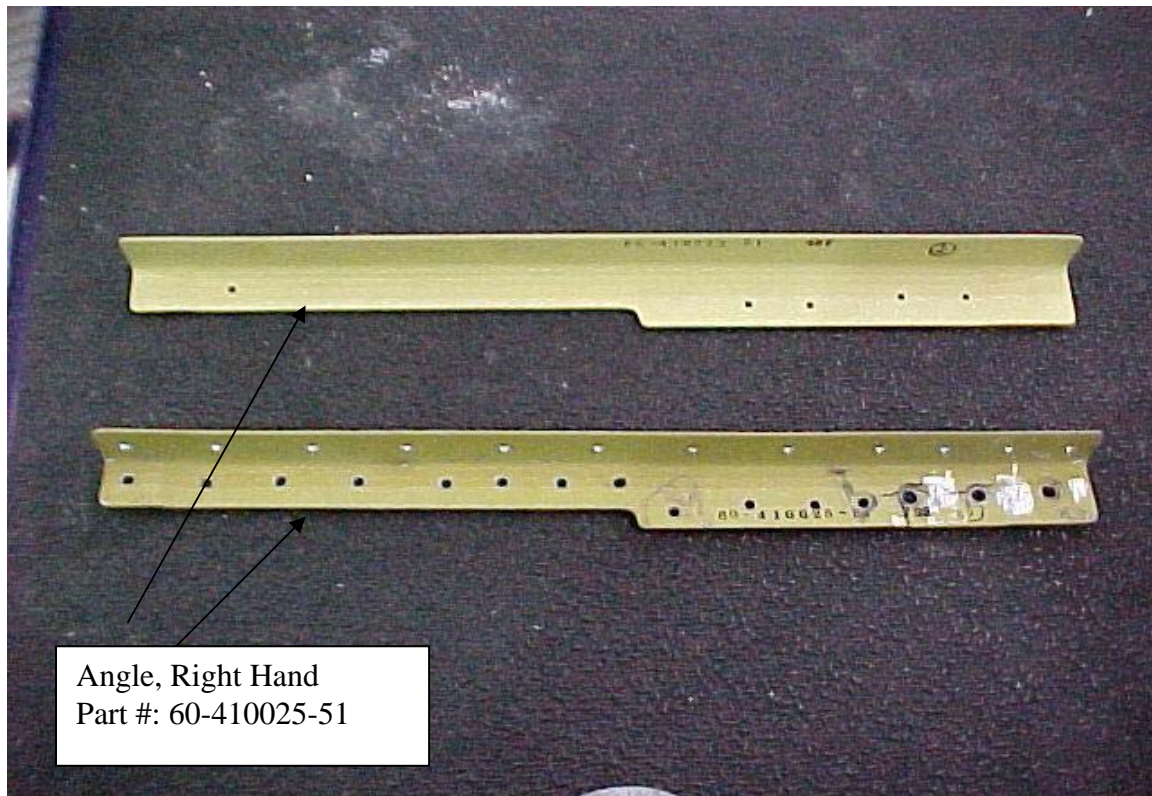
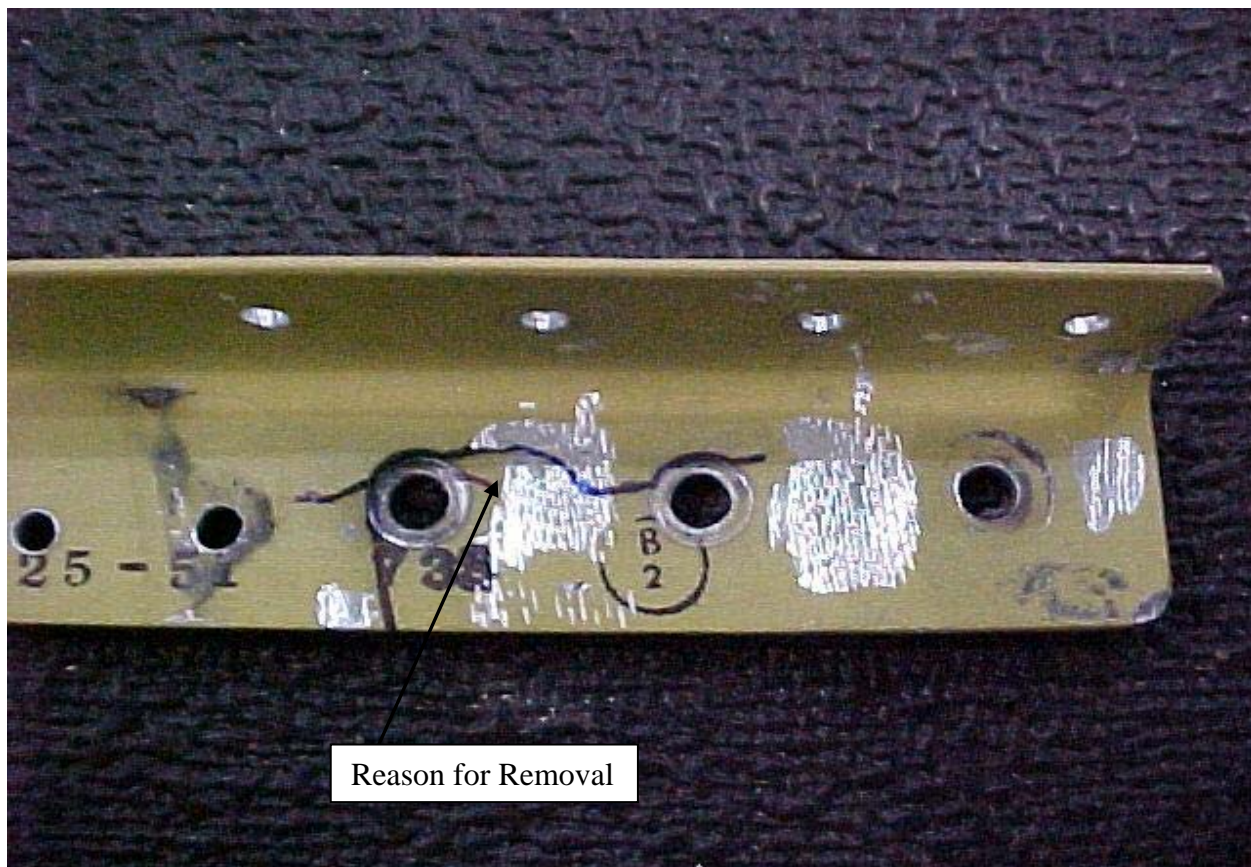
An annual inspection revealed a cracked stiffener (P/N 60-410025-51) under the R/H nose baggage floor (station 67: between the main and standby inverters). Cracks were found around this part's Hi-Lok fastener holes.

The submitter states, "Removal of *(this)* stiffener allowed inspection of the keel (P/N 60-410025-601) revealing cracks in *(its)* web previously obscured by the installed stiffener. The mirror image stiffener (P/N 60-410025-49) on the left side of the aircraft revealed similar cracks, *(but)* with no damage to the keel."

"The *(attached)* pictures are described as follows: picture (1) is a view of the right side keel web (cracked) as taken from inside the nose baggage compartment. The baggage floor *(has been)* removed, and the top of the picture is the support for the nose baggage floor. Picture (2) I realize is out of focus, but it is *(submitted)* to provide some reference. *(This second photo...)* is taken from inside the nose wheel well. *(The view...)* is looking toward the right side of the aircraft, *(showing...)* dye penetrant seeping in from behind a support that obscured the crack in the keel. Picture (3) *(...views both the new and old parts)*. Picture (4) shows in great detail the crack that was the cause for *(the part's)* removal.

"The reason I felt compelled to submit this report is this *(aircraft)* is the second B60 *(...on which I have performed an annual inspection)*, and both had the same stiffeners cracked. I do not currently have any information regarding total times on the other Duke having this problem...." "All of the cracks were visible with the naked eye—the dye penetrant was used only to highlight the defects for the camera." *(Photos have been slightly "tweaked" to save space—Ed.)*

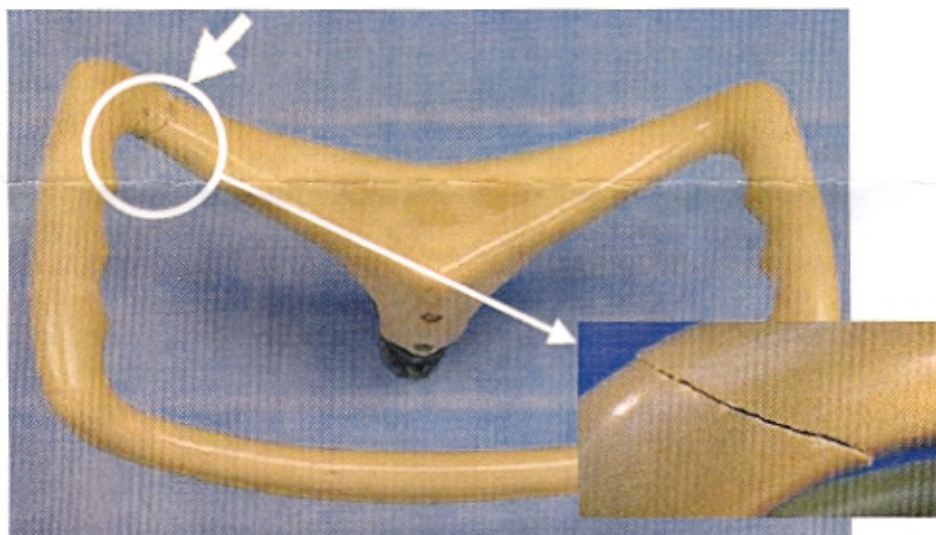
“The National Transportation Safety Board (NTSB) recently sent a safety recommendation to the FAA regarding cracks and failures of plastic control wheels on Cessna single-engine airplanes. The recommendation was due to a non-injury airplane accident in Colorado on a 1962 Cessna 205 in 2004 that resulted in damage to the firewall, propeller, and wing strut. The pilot reported that the control wheel fractured during the landing flare. The NTSB recommends that the FAA ‘Require recurrent inspection of part number 0513166 series control wheels in applicable Cessna airplanes for cracks, with specific emphasis on the inside upper corners where fatigue cracking has been found and replacement of the control wheels if any cracks are detected.’

“In the past 32 years, 16 occurrences of cracks or failures of P/N 0513166 control wheels were found in the Service Difficulty Report (SDR) database. Also, 5 occurrences were found for P/N 051367, 13 occurrences were found for P/N 0513168, and 10 occurrences were found for ‘control wheel’ without a part number. Thus, a total of 44 occurrences were found.”

“FAA Special Airworthiness Information Bulletin (SAIB) CE-01-41-R1 states in the recommendation: ‘The FAA recommends that owners, operators and maintenance technicians place special emphasis on the periodic 100 hour and annual inspections on plastic control wheels installed in these airplane models until they are replaced with metallic control wheels. See Cessna SL No. 64-8, dated February 14, 1964, for airplane Model and Serial Numbers. If the indication of cracking is unclear, we recommend that you proof test the wheel in accordance with Cessna SI No. 64-8. However, the pull force may be reduced to 30 pounds rather than the 50 pounds as stated in the service letter. If replacement is required because of the failure of the control wheel due to this pull force, then it is to be replaced with a metallic control wheel, as specified in the service letter.’

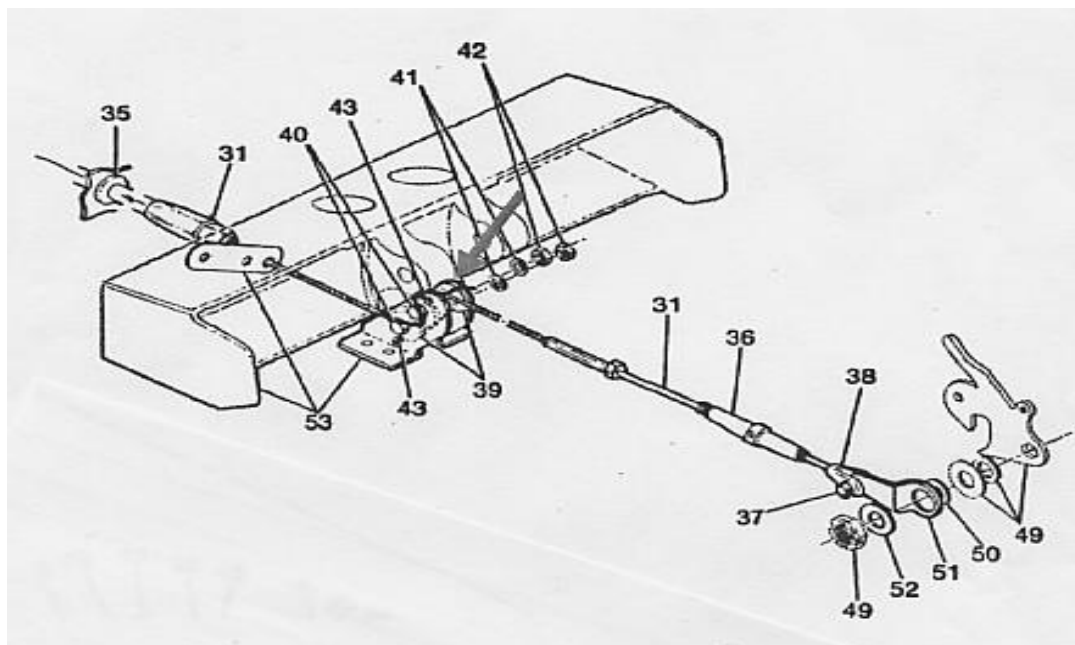
“While preparing to land,” states the submitter, “the pilot was unable to position the nose landing gear in the down-and-locked position. Following a landing in which the nose gear collapsed, it was found that the retractable cabin step cable failed at the forward pulley (P/N 51710-1). The cable intertwined with the nose gear linkage and would not allow the nose gear to lock in the down position. The main landing gear operation was not affected. The cable (P/N 1211504-1) was installed on the airplane 8 years prior to the accident.” *(Aircraft total time was given as 7,500 hours.)*

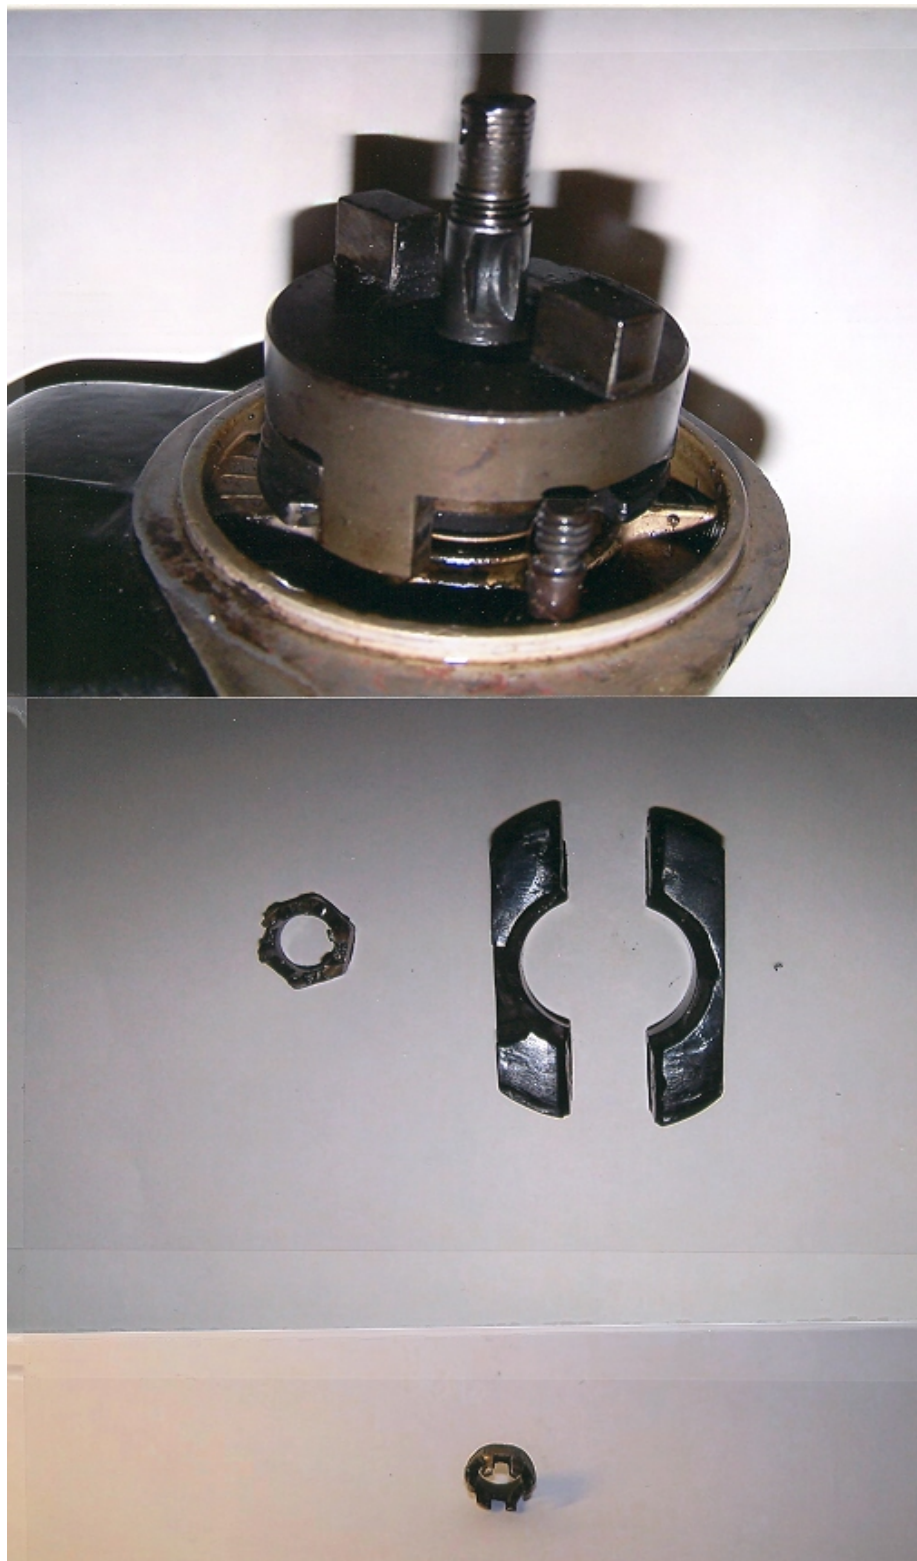
The attending mechanic writes, "This magneto was removed from the engine for routine maintenance and inspection. The threads on the magneto shaft and nut were completely stripped *(and)* the slot in the shaft for the Woodruff key was wallowed out. The cotter-key retaining the nut to the shaft was still in place. At the time of removal the engine was operating normally. Only the magneto bushings and retainer were holding the impulse coupling in place. It is my opinion that the drive shaft and/or the Woodruff key were defective at the time of manufacture. Undetected, this condition can lead to complete engine failure."

*(This magneto belongs to a Lycoming O-540-B2C5 thrusting a Piper PA-25.)*

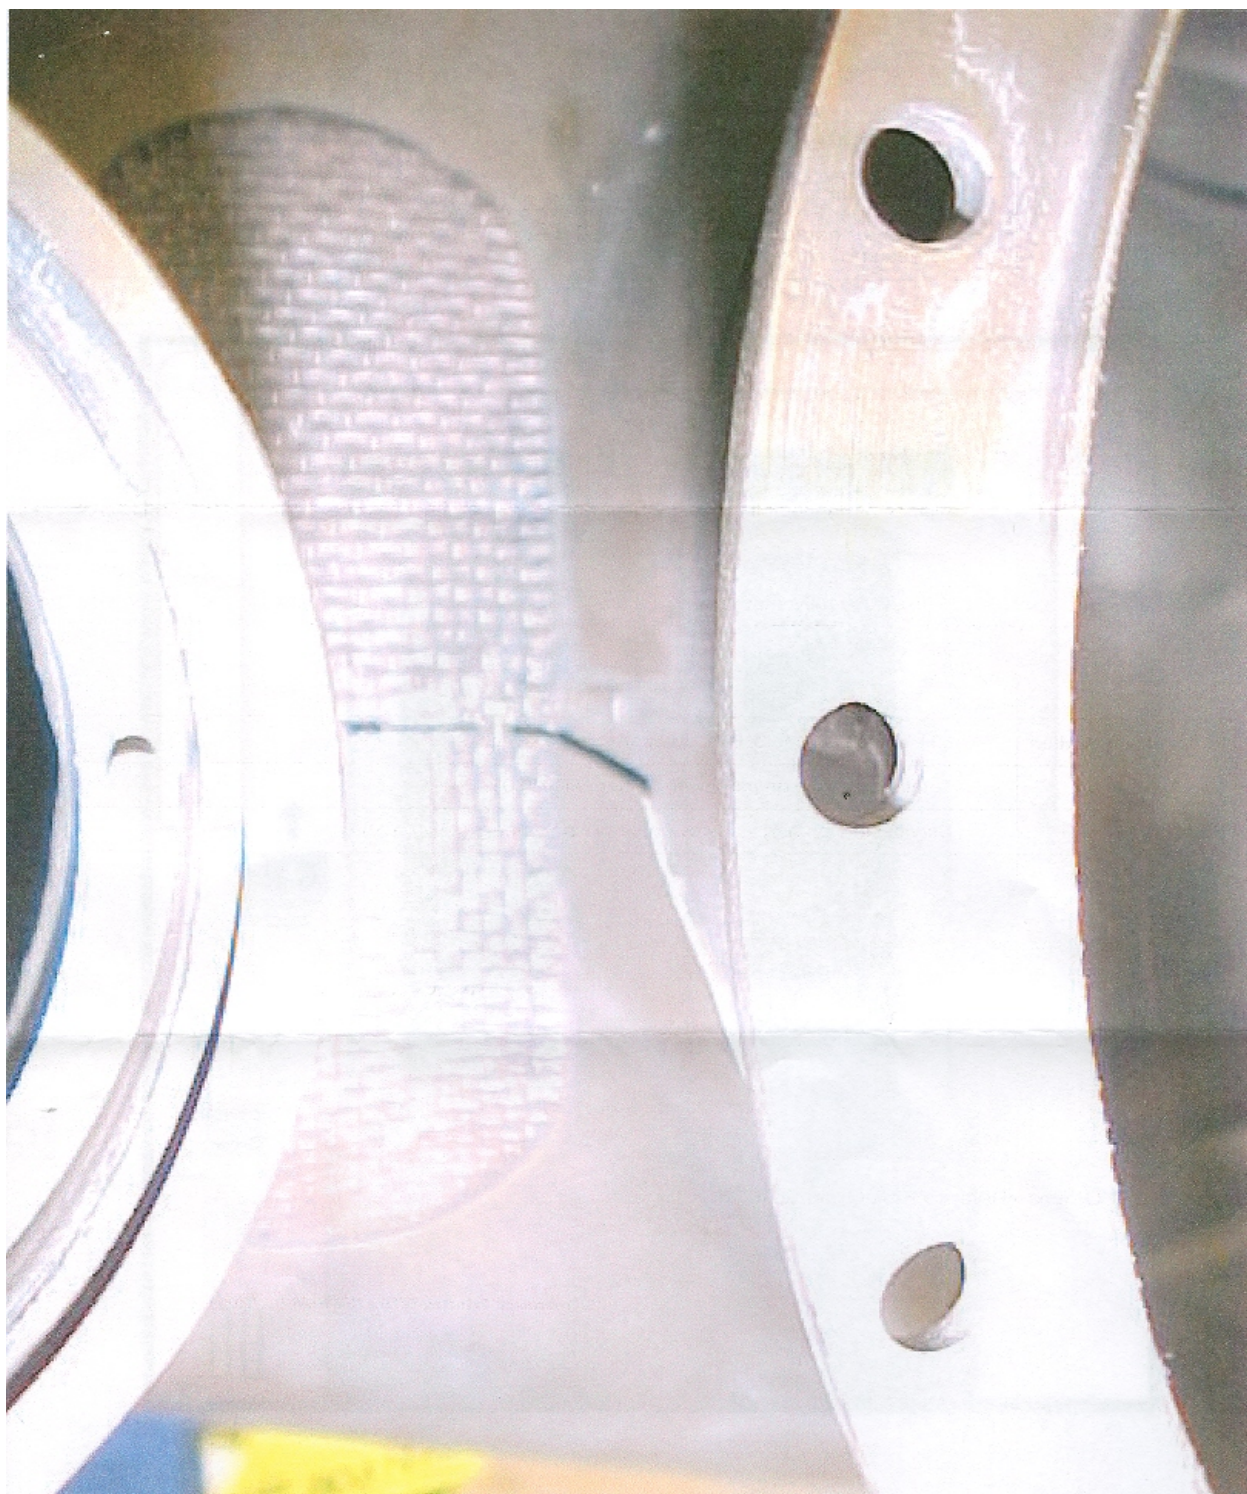
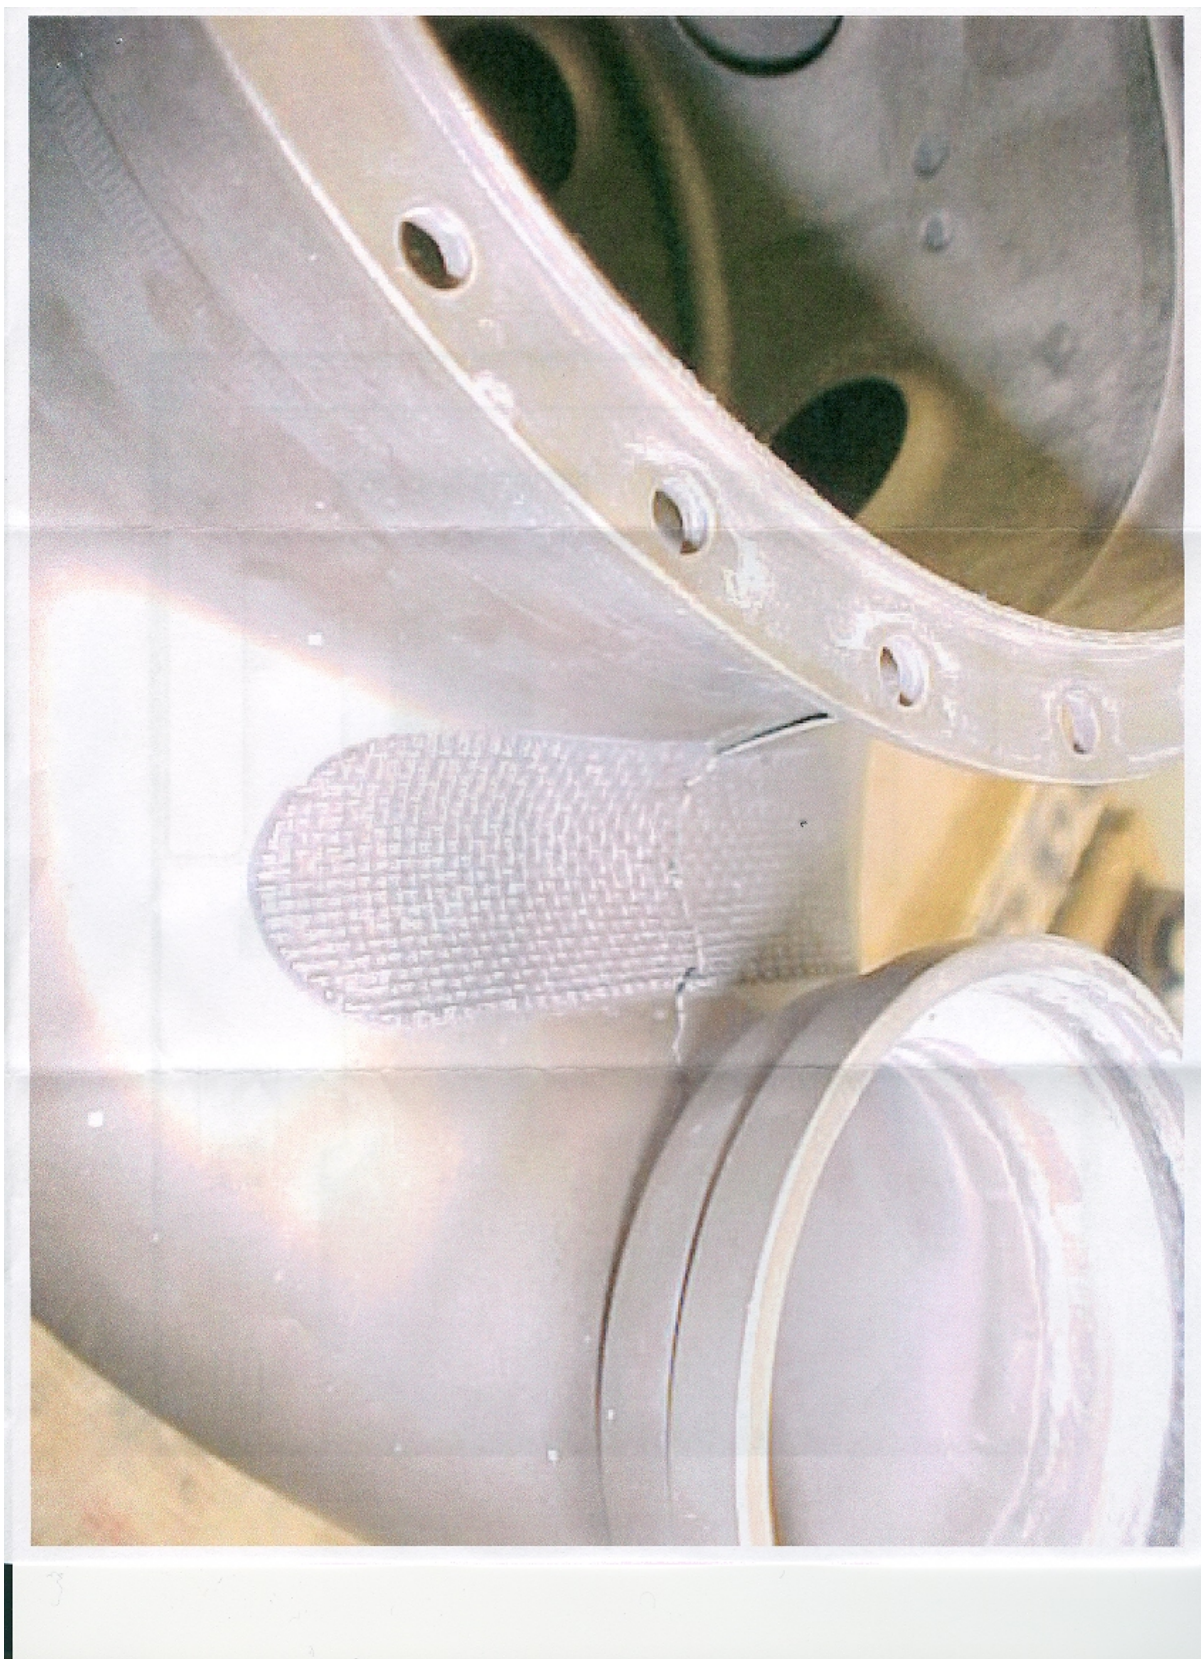
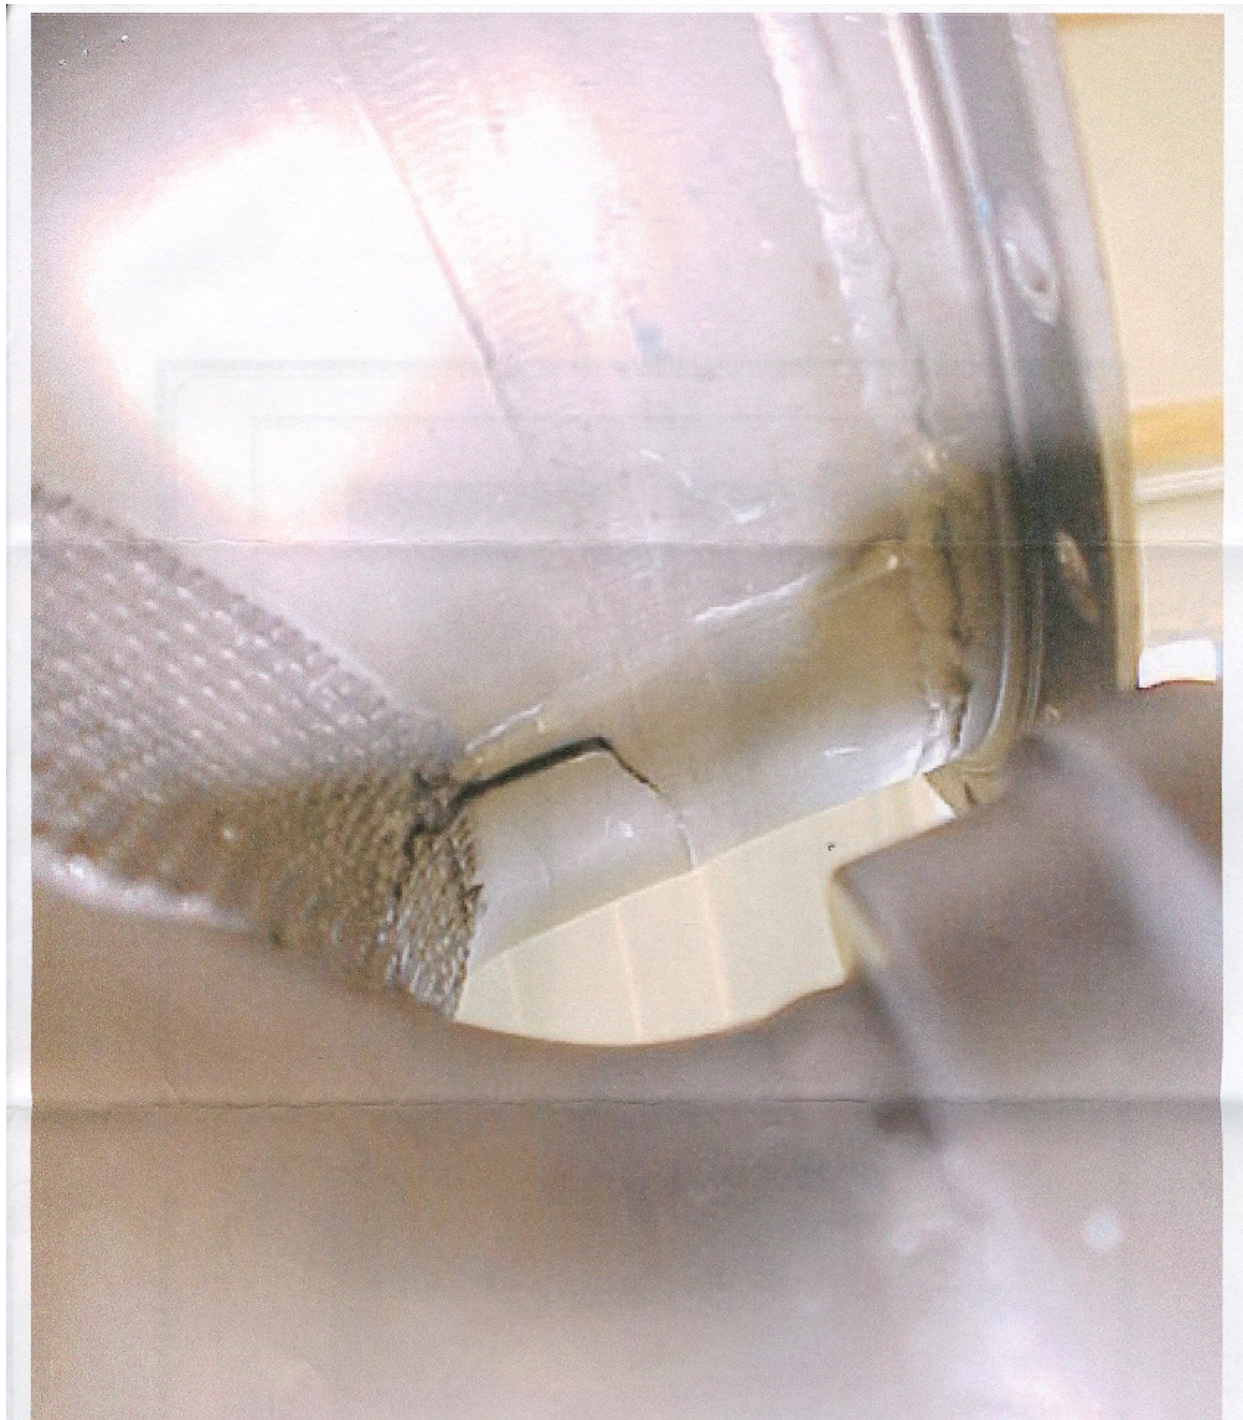
A helicopter mechanic relates his pilot's complaint "...that the TOT (*turbine outlet temperature*) suddenly went 40 degrees Centigrade hot. (*Inspection*) found the combustion can (*P/N 6870992*) cracked. The unit was replaced."

*(A search of the FAA Service Difficulty Reporting System data base revealed 20 separate reports for this P/N since 1993.)*
